Lower Country Club Community Stormwater Summary

Washoe County
Incline Village General
Improvement District

Nevada Tahoe
Conservation District

**Lower Country Club Community Stormwater Summary
February 2015**

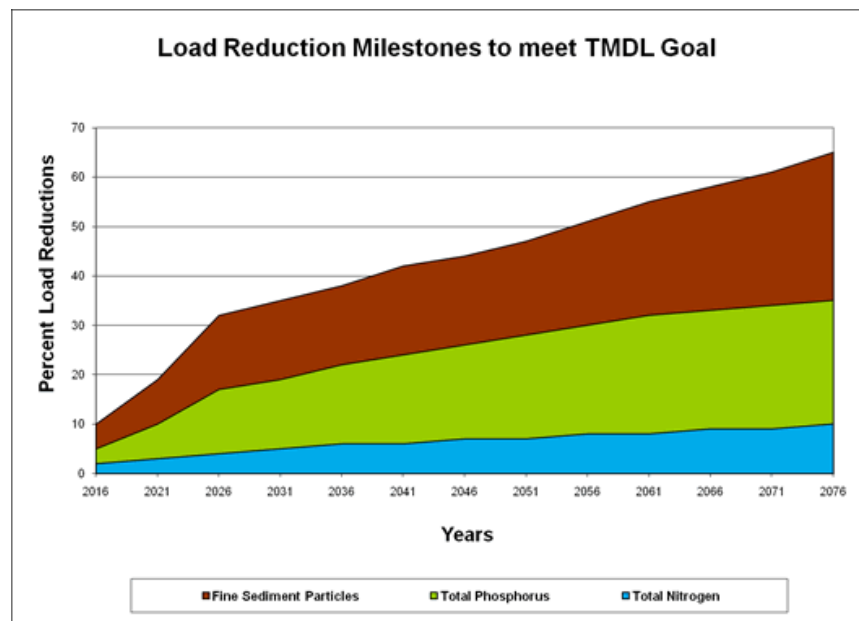
Figure 1: Load Reduction Milestones for Lake Tahoe

The goal of the Lake Tahoe TMDL is to restore the Lake to its historic water clarity level of 97.4 feet. It established thresholds of pollutants (namely fine sediment, nitrogen and phosphorus) and calculated the load reductions needed from the four largest sources (urban and forest stormwater runoff, stream channel erosion, and atmospheric deposition) to achieve the TMDL by 2076. The Clarity Challenge was created as an interim goal to the TMDL numeric target. This goal is to meet

a target of 78 feet of lake clarity by 2026 and considers opportunities for achievable load reductions in all source categories.

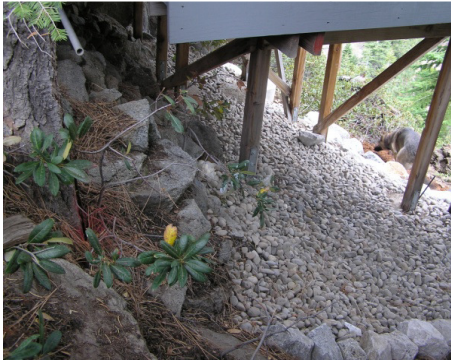
Figure 16: Armor under elevated

impervious surfaces including drip lines, elevated structures, driveways along with stabilizing slopes and other bare soil areas. Maintenance of existing system will include refreshing these systems and ensure they are properly functioning.

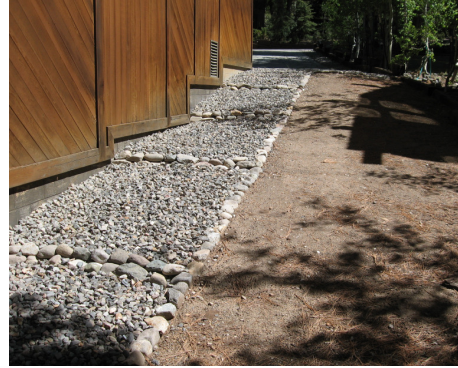
Figure 17: Armor under drip line
